**2015
DORSET ARCHAEOLOGICAL AWARD**

**DRUCE FARM ROMAN VILLA
ARCHAEOLOGY PROJECT
2011 - 2015**

EAST DORSET ANTIQUARIAN SOCIETY

**Date: 16th August
Version: 1.0**

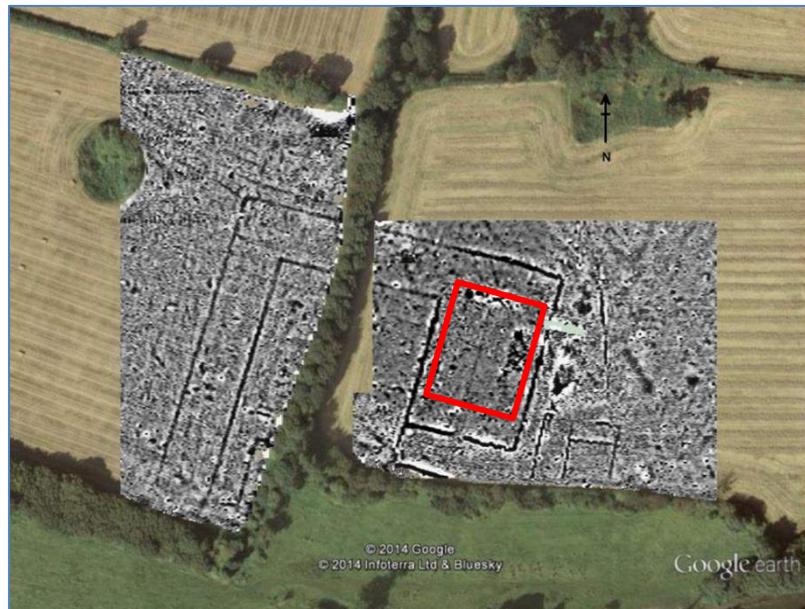
Fig-1: Geophysical survey showing the extensive system of enclosure ditches. The villa is situated within the highlighted area.

A complex system of large, deep ditches encloses the villa complex (Fig-1) and extends into the adjacent field. Excavations have confirmed a sequence of cutting, infilling and re-cutting throughout the Roman period.

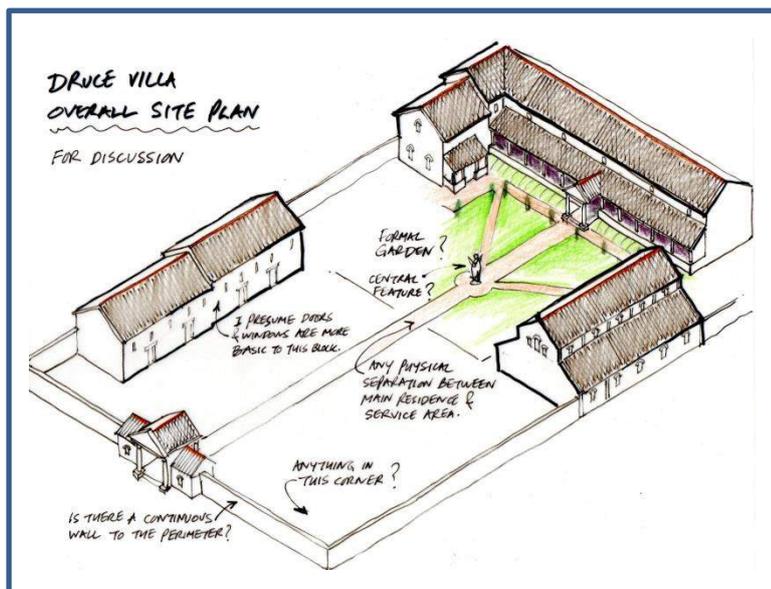
Fig-2: Preliminary sketch of the villa complex - [work in progress], courtesy Gareth Naylor.

The villa comprises three sets of buildings arranged around a central courtyard. The area is delineated by enclosure ditches, and to the south was a probable monumental entrance. The villa complex is constructed on a slope with a drop of approximately seven metres from north to south.

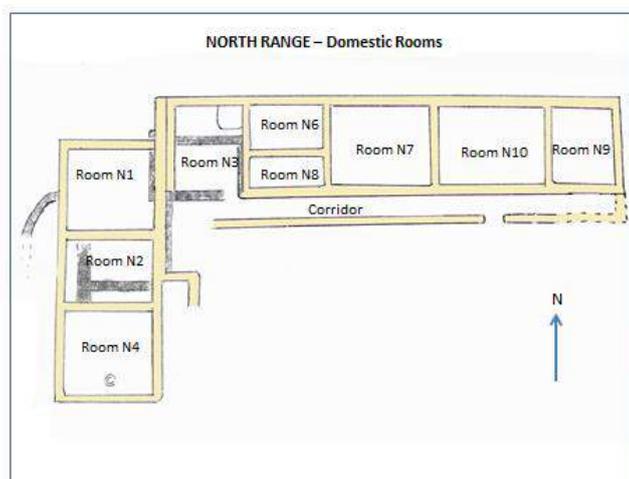
Fig-3: Schematic plan of the North Range.

The building has a total length of 35m and a width of 8m. Eleven rooms have been uncovered, demonstrating a complex sequence of alteration and re-building, as can be expected over 400 years of occupation.

External and internal walls are constructed of mortared flint throughout. The earliest walls are the most carefully constructed with flint laid in a herringbone pattern and embedded in thick, hard mortar; the corners are reinforced with ashlar. Later walls are less well made, often containing re-used building material, such as fragments of tile and building stone.

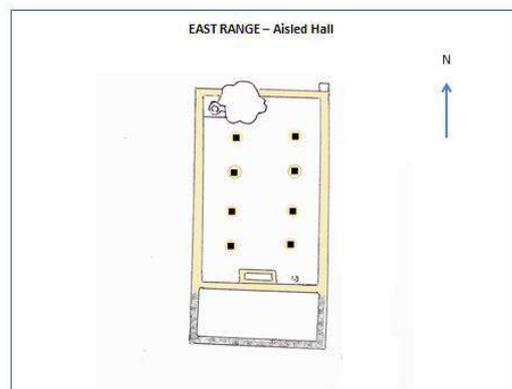
Fig-4: Schematic plan of the East Range.

The east range comprises a very large, flint-walled building, measuring 24m long by 11m wide. It has been rebuilt at least twice. This aisled hall is perhaps the most impressive structure on the site, built in the style of a Roman basilica, similar to the nave of a church.

It contains at least eight flint-packed foundation pits (approx 0.5 metres deep) on which stood square stone plinths for massive timber uprights which supported the roof. The one plinth that still remains is unique in that it exhibits a cut measuring a Roman square foot.

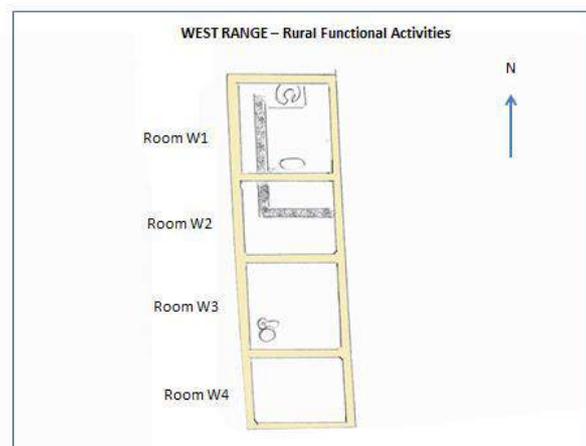
Fig-5: Schematic plan of the West Range.

The west range comprises four rooms used as workshops. At least two phases of building have been identified to date.

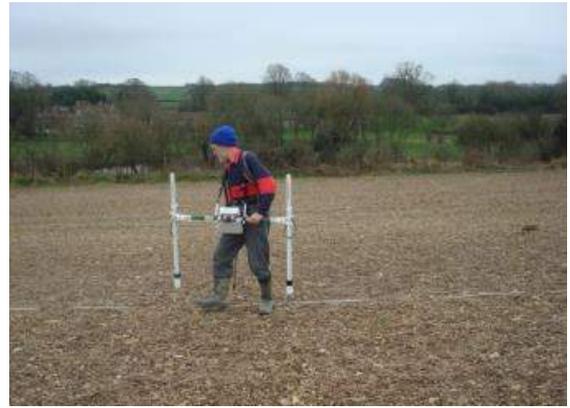
Image-2: Magnetometry survey undertaken by Dave Stewart 2012

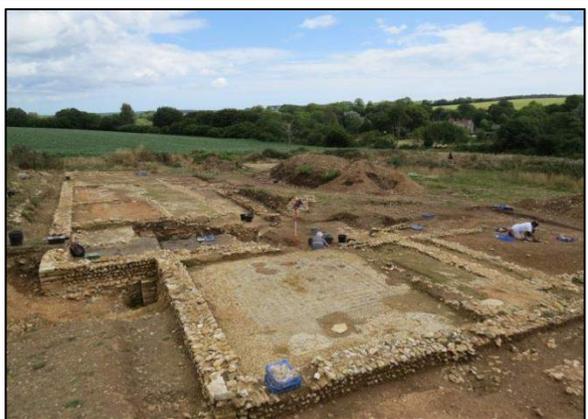
Image-6: North Range in 2015

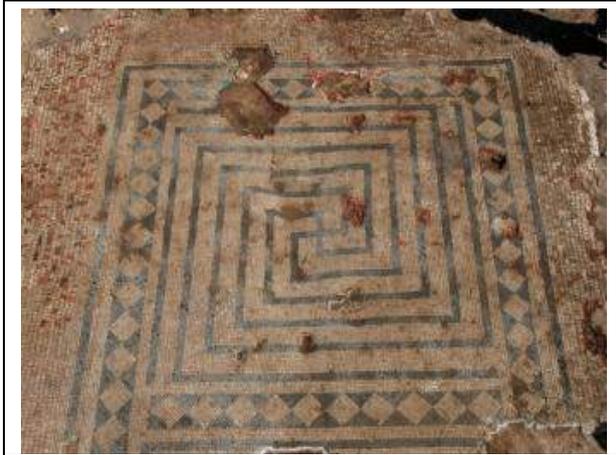
Image-7: Mosaic pavement in Room N1

Room-1: This room contains an intact mosaic. The simple geometric design of two meandering lines following a right angled concentric path, crossing at the centre forming an inverted swastika, in blue lias and white limestone tesserae. The borders consist of larger limestone tesserae with random red ceramic pieces. Mr Anthony Beeson described it as “an elegant mosaic and of a style suggestive of Roman Villas in the vicinity of Ilchester”, and he praised the high standard of craftsmanship. It was probably laid c. AD 350. A terracotta fillet divides the wall from the floor.

The western part of the mosaic had been crudely repaired several times during the life of the villa. The damage was probably caused by the movement of a piece of heavy furniture such as a bed or couch. These repairs are estimated to have been made in the 5th or 6th centuries.

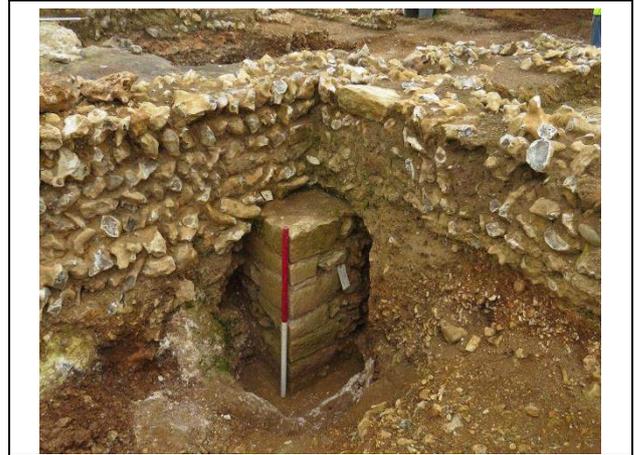
Image-8: Ashlar quoin at corner of two walls defining early building phase of Room N3. Under fine herringbone wall

The first phase is marked by a floor cut into the chalk bedrock and an east-west wall defining the south of the room. The west corner was constructed of ashlar and a further wall runs to the north where it ends at another corner constructed of seven layers of

ashlar. A second east-west wall runs across the centre of the room and was built on the chalk bedrock.

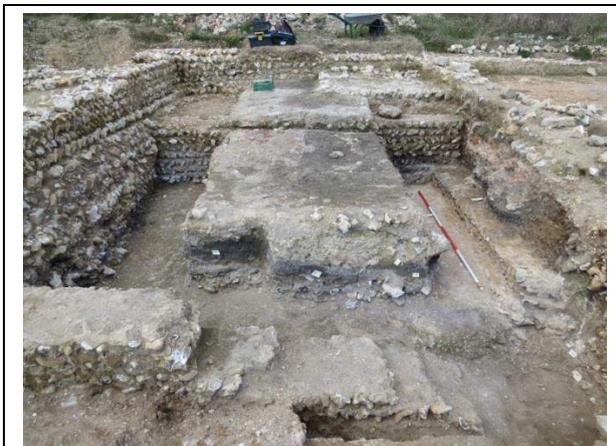
Image-9: Complex structure of Room N3, with raised floor that has collapsed and early phases of walls built on chalk bedrock.

A later phase of building occurred when new walls were erected to extend the width of the room. The west wall shows two styles, the lower part is coarse and wide, suggesting it was to be covered by the infill, whilst the carefully made upper section is built in a herringbone bond.

The floor level was raised by bringing discarded material, such as demolition debris and black ash, from several locations on the site; this is visible as discrete layers.

There is evidence of two catastrophic events in this room. Before the rammed chalk floor was applied there was a fire evidenced by an extensive area of burnt hoggin, burnt clay, mortar and flint nodules along the north-south wall. The chalk floor was then laid. But before the room could be finished, the southern section of the floor collapsed, dropping by up to 18 cms. This was due to the inappropriate nature of the infill material. Thereafter the room appears not to have been used for domestic purposes but was levelled roughly with building material and a further crude rammed chalk floor created. A sub-square arrangement of flint nodules set in cob was assembled in the north east corner of the room, its purpose not known.

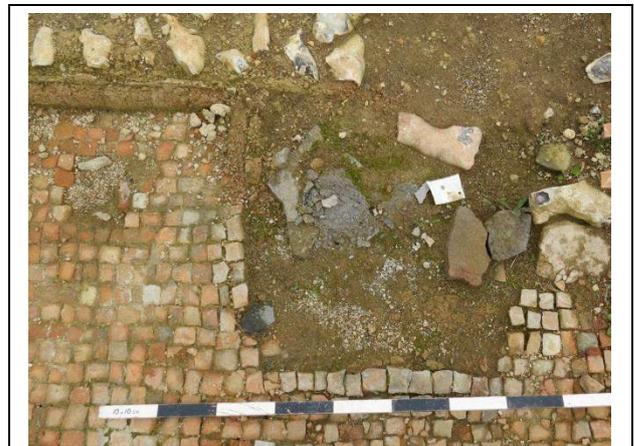
Image-10: Room N4, a fireplace of the east wall, with fragments of a fillet and a mosaic of red ceramic tesserae.

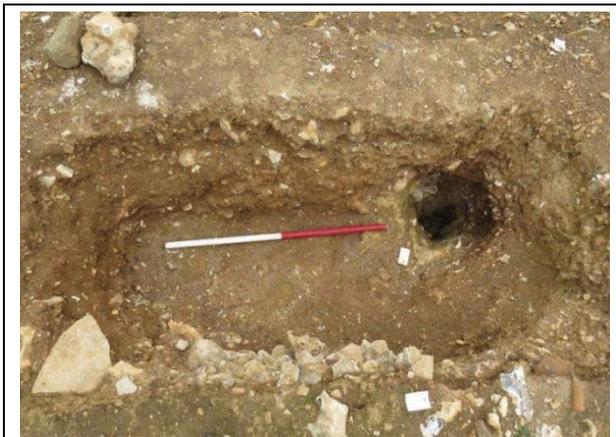
Image-11: Room N10 with a late well cut elongated pit, and deep post hole, which was subsequently re-filled with building material. No other finds.

On the eastern edge of this room there is a substantial pit that was re-filled with building material.

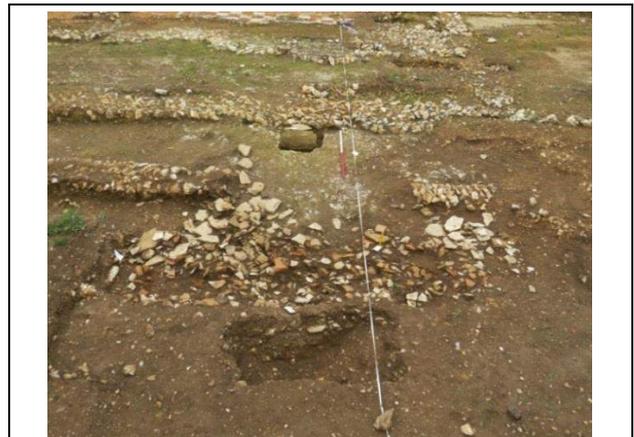
Image-12: The Corridor, with doorway into the north range with rammed chalk floor, a large fragment of a potential pillar and evidence of a collapsed roof with decorative yellow sandstone roof tiles.

Corridor: along south of the north range is a corridor. It has a porch structure with a doorway (possibly with double doors) that would have led out into the courtyard. The corridor is likely to have been open. Part of a stone pillar, found in Room-1, is a remnant of the pillars that may have lined this space. There is a concentration of roofing material suggesting the porch contained some yellow sandstone roof tiles used for decorative effect.

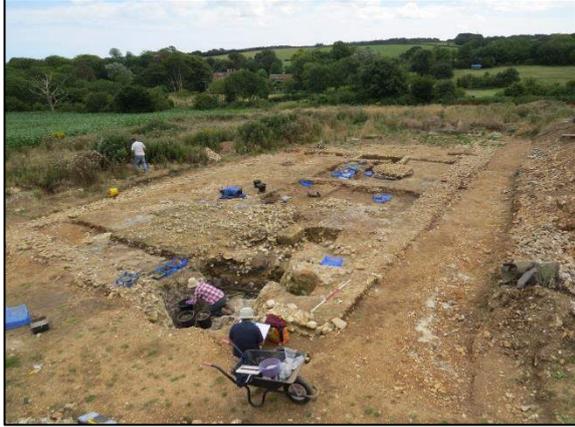
Image-13: East Range – the aisled hall in 2015.

The internal structures of the building are still being examined, but potential room configurations are being identified. It is likely that the hall was shortened in a second phase rebuild when a substantial east – west wall was inserted three quarters of the way down the building. The south eastern end of the hall has been much damaged by deep ploughing.

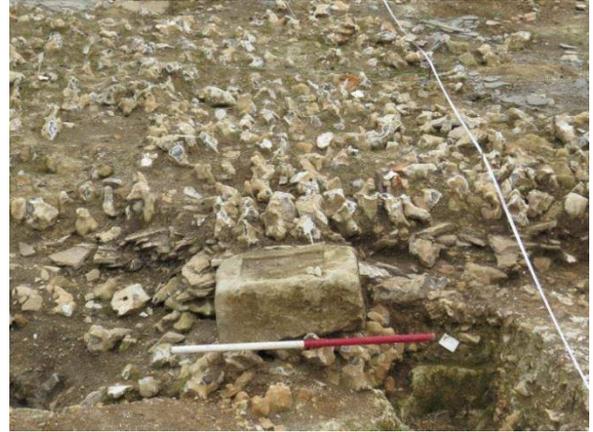
Image-14: a stone plinth sitting on a flint foundation. Behind is a collapsed gable wall, with aligned flints and putlogs.

At the northern end is a rare example of a collapsed gable wall which fell intact – frequently in the past these features were not been recognised and were removed as building debris. A series of putlog holes, filled with fragments of tegulae, show where scaffold timbers were placed to support wooden plank scaffolding. There are also corresponding post holes outside the foundations of the wall where the scaffold was erected.

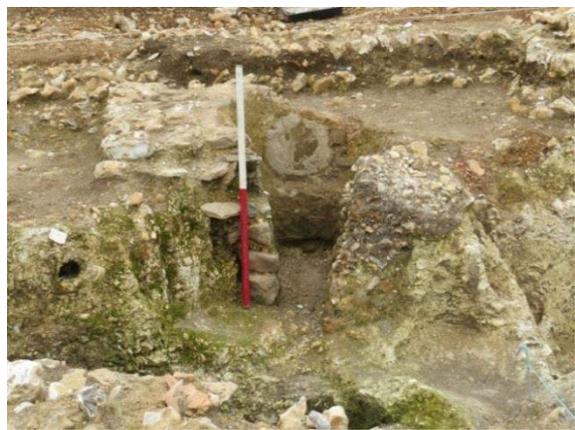
Image-15: East Range – a large domestic oven.

In the north-west corner a large domestic oven was contemporary with the latter phase of construction.

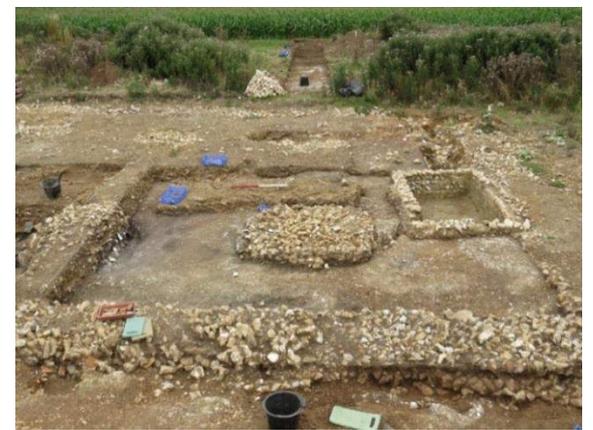
Image-16: East Range - a chalk floor abuts a flint foundation pit, and a waterproof tank lined with opus signinum, of unknown purpose.

Various floor levels have been encountered as well as infill layers. There is an enigmatic tank structure within the building. Its purpose is not known but it was lined with waterproof *opus signinum*, it may have been an internal water feature or it may have had an industrial purpose.

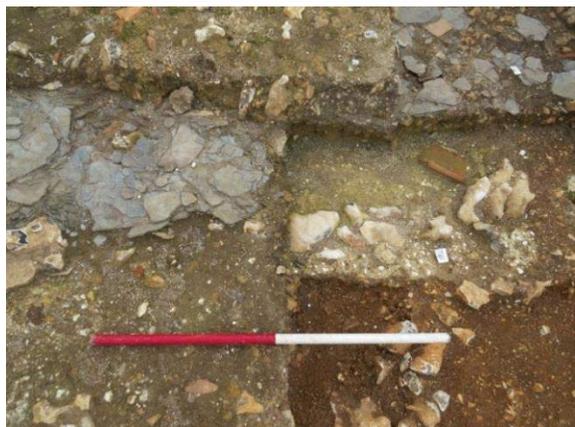
Image-17: East Range – the collapsed wall overlays a layer of slate roof tiles fallen onto an internal wall of flints set in chalk cob.

The roof was a complex structure of limestone tiles and wide bands of rare and expensive Cornish slate that were sourced from Delabole quarry. There were also ceramic tiles running along the ridge.

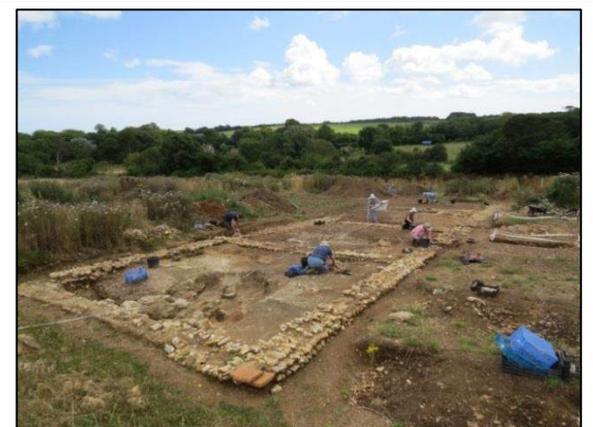
Image-18: West Range of workshops in 2015.

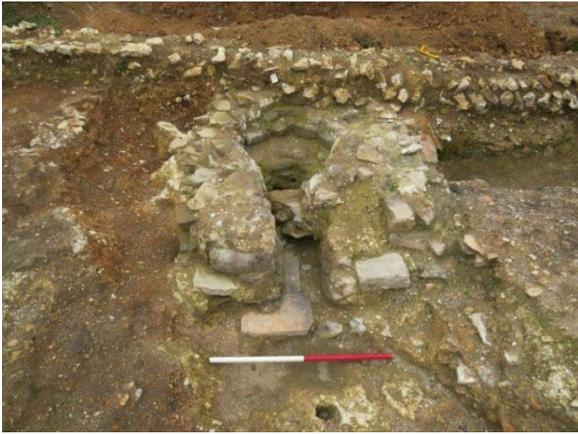
Image-19: In Room W1 a large carefully constructed industrial oven. Use not known.

Room W1: This room contains a very large stone-built oven which was subjected to intensive heat. The structure belongs to the first phase of the building and was covered by a later chalk floor.

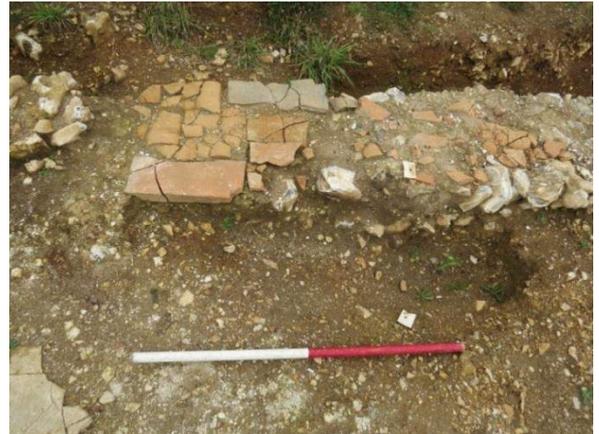
Image-20: In Room W1 tile fragments for levelling under threshold of doorway. To right cut for infant burial.

On the eastern wall is evidence for a doorway: ceramic tile fragments were arranged to provide a level surface for a threshold, since removed.

This room contains the remains of two infant burials cut into the floor level.

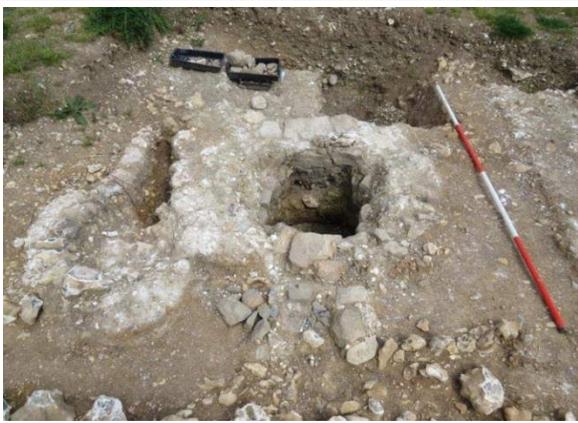
Image-21: In Room W4 an oval shaped stone feature, possibly a well and small oven to left.

Room W3: This room exhibits two intriguing structures, a tiny oven and a structure which possibly was used as a well.

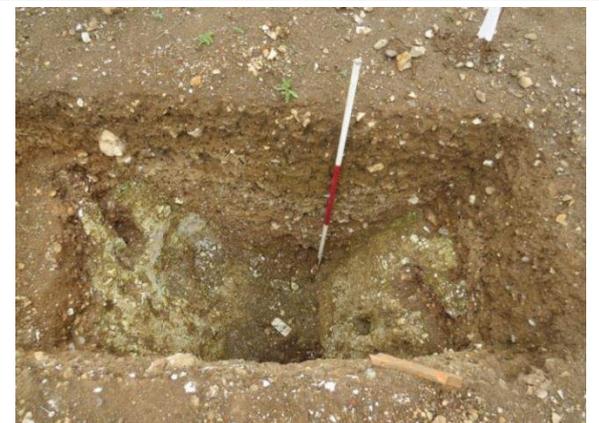
Image-22: Deep 1.5m section of enclosure ditch outside West Range.

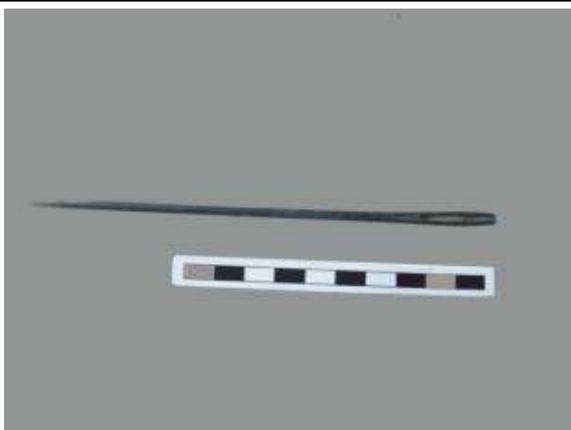
Image-41: Bronze leather-working needle from the fill of the western ditch

Metalwork: The metalwork includes copper alloy hair pins, a leather working needle, a silver ring with a (broken) blue glass intaglio, and several decorative fragments of bracelets.
